Urban Building Damages in Sichuan Earthquake and Seismic Design Countermeasures in Reconstruction

Summary

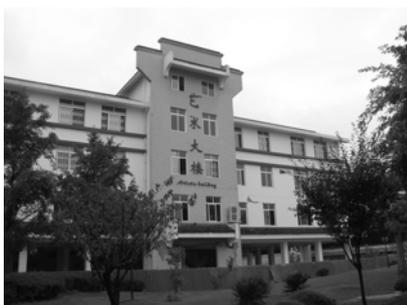
Fig. 1 Elevation of the damaged Primary School Fig. 2 Construction of the retrofitting damper bracings

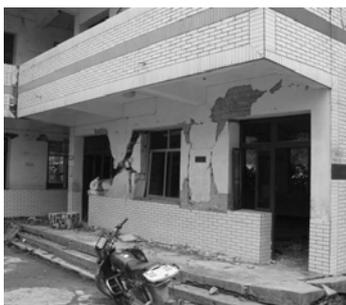
Fig. 3 Damaged building of Xiang'e Primary School Fig. 4 Construction of New Xiang'e Primary School
