## Economical and Ecological Analysis of a Pedestrian Bridge made of Textile-Reinforced Concrete

On the example of a 97 m long TRC pedestrian bridge, which was built in Albstadt, Germany, this paper shows briefly the design and construction of the TRC superstructure. Furthermore, details on the sustainability are presented: The emission of carbon-dioxide in the production process can be reduced and due to the low maintenance, costs can be decreased allowing for an economic construction.

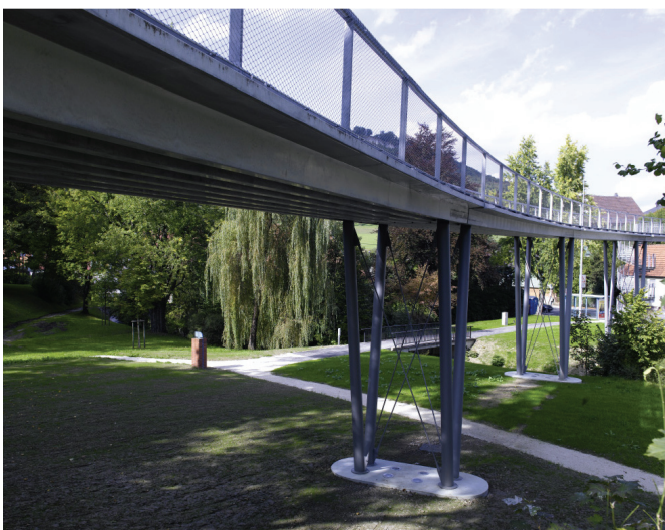
Fig. 1: Pedestrian bridge in Albstadt, Germany

consequence is that these structures have to be improved by cost-intensive actions or replaced by new structures. One example of an older pedestrian bridge, which is damaged by corrosion of the reinforcement, is the pedestrian bridge over a state road in Albstadt, Germany. Due to the immense corrosion damages, this bridge had to be torn down and was replaced by a new bridge, Fig. 1.

The superstructure of the new bridge is made of textile-reinforced concrete (TRC) fulfilling demands on a frost-resistant construction. The main advantage by using technical textiles like alkali-resistant glass (AR-glass), is the possibility of reducing concrete covers to a minimum, because the corrosion protection as it is known for steel reinforcement is not required here. The
