Monitoring fatigue effects in an orthotropic steel bridge deck

Keywords: fatigue; steel bridges; orthotropic steel decks; dynamic identification; retrofit.

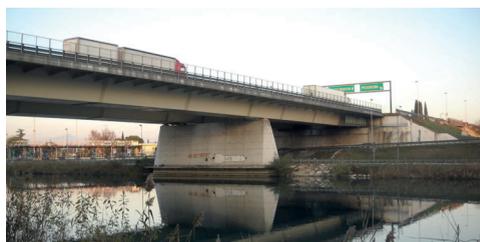
Fig. 1: The steel bridge over the Mincio River

steel bridge crossing the Mincio River in Italy, affected by fatigue problems, is presented (Fig.1).
