Structural analysis of a historical masonry arch railway bridge in Gata de Gorgos, using a generic finite element analysis software

Pablo Tarín, Alberto Ordiñana, Fernando Ibáñez

Abstract

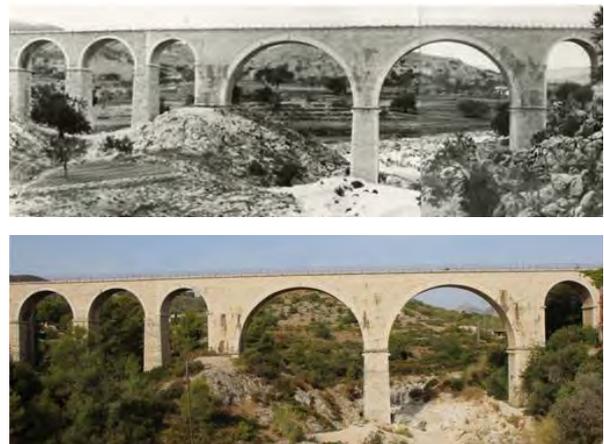
This viaduct, a set of masonry arches designed by the mining engineer José Carbonell and completed in 1913, is divided in four approach spans composed of 10-meter rounded arches and the section over the river itself, composed of two 20-meter rounded arches flanked by 8-meter rounded vaults. The whole length of the viaduct, considering

the abutments and the retaining walls, is around 165 m. See elevation of the viaduct at fig. 1.

Figure 1. Elevation of the viaduct over river Gorgos in the middle XX's (left) and nowadays (right)
